From Nick MacKinnon (Editor) WTRG
 Upper Heights Farm, Stanbury, BD22 0HH
 01535 649359

Material errors in the PEIR for Calderdale Energy Park

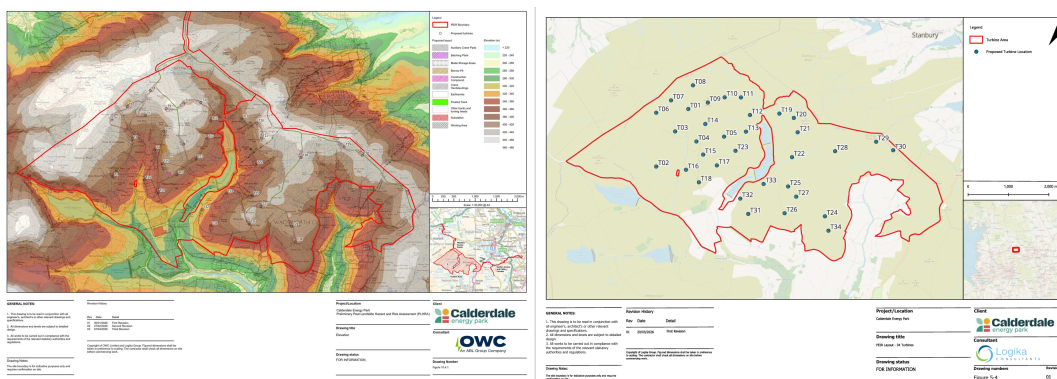
The PEIR contains many maps including a set of maps with high precision engineering drawings of the infrastructure. An example, figure 10.4.1 is shown below. There are also maps with lower precision showing the layout. An example (fig 5-4) is shown below.

These, and many other maps, do not correctly represent the geospatial data given in table 4-1. The largest discrepancy between the maps and the geospatial data is over 220 metres at T28.

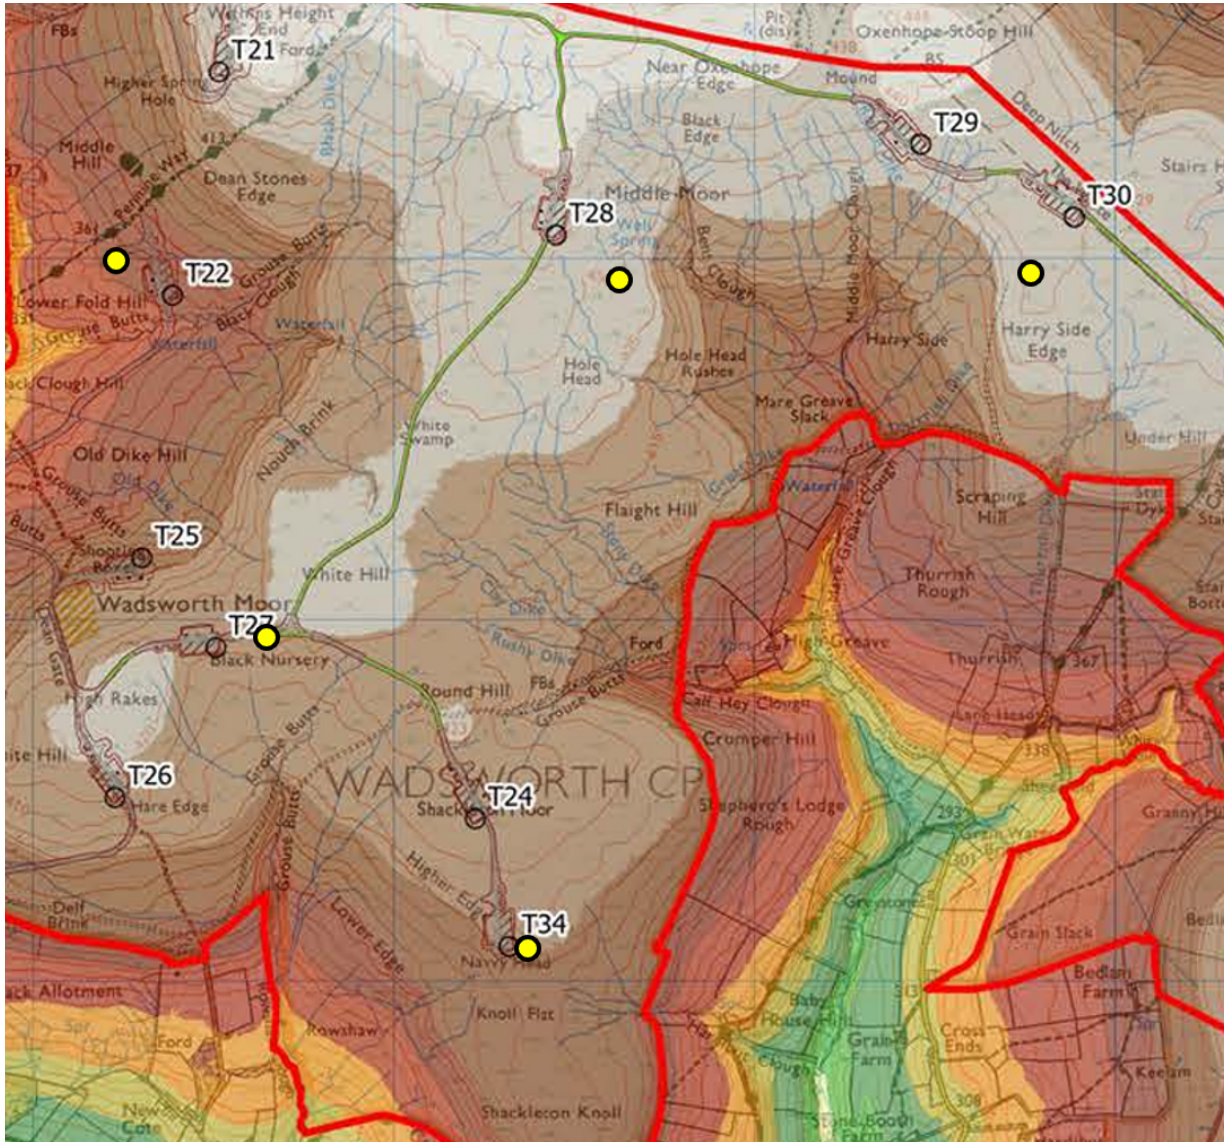
The errors are considerable in the turbine area east of the Walshaw Dean Reservoirs. Our map below plots the geospatial positions given in Table 4-1 using a yellow dot in a black boundary.

Variation between geospatial Table 4-1 and the geospatial map 10.4.1. The yellow dots are the positions of the turbines as given in Table 4-1. The black circles are the mapped positions. The maximum error is 220 metres at T28.

The error at T22 impacts analysis of the proximity of T22 to the Pennine Way. The distance of the correct position (yellow dot) from the Pennine Way is 71 metres, which means the blades of the candidate turbine (Vestas 7.2/160) used for modelling noise in the SR, for example would oversail the national trail. A safe setback would be tip height plus 10% which is 220 m.

The error at T30 impacts calculations of the visual dominance of T30 over the King's Bradford Pennine Gateway NNR at Penistone. It is not known if the wire diagrams provided in the PEIR use the correct coordinates.

Peat slide analysis of the ground under the track to T22 cannot be checked because of the 175 metre error in the position of T22 in the maps of Factor of Safety in Appendix 10-4.

Given the vast weight of maps listed below, it would be easier for CWF Ltd to bring Table 4-1 into line with the maps rather than vice versa. The Statutory Consultees cannot be expected to double guess this matter. The statement of the PEIR is that the Table 4-1 is primary, and statutory consultees must use the table to do their analyses or they are reduced to estimating turbine locations from maps that are wrong.

We recommend the PEIR is withdrawn and the Statutory Consultation is suspended until CWF Ltd have revised the whole PEIR with reasonable care. The public meetings that have been held so far at Denholme, Oxenhope and Hebden Bridge should be re-run on the basis of a PEIR that CWF Ltd have revised with reasonable care. All Statutory Consultees should be informed of the errors. The public who have been sent brochures should be sent an acknowledgement of the errors in the turbine locations and an indication of which information is reliable: the millimetric turbine locations or the maps.
